COST AND PERFORMANCE REPORT

This report presents cost and performance data for a composting application at the Dubose Oil Products Co. Superfund site, in Cantonment, Florida. Composting was used at the Dubose site to treat soil contaminated with polynuclear aromatic hydrocarbons (PAHs), pentachlorophenol (PCP), and volatile organic compounds (VOCs), including benzene, xylene, trichloroethene (TCE), and 1,2-dichloroethene (DCE). The specific PAHs of interest at Dubose were acenaphthylene, acenaphthene, anthracene, benzo(a)anthracene, benzo(b and k)fluoranthenes, benzo(a)pyrene, benzo(ghi)perylene, chrysene, dibenz(a,h)anthracene, fluorene, fluoranthene, indeno(1,2,3)pyrene, naphthalene, phenanthrene, pyrene, and 2-methylnaphthalene.

Dubose Oil Products Co. Superfund Site
Cantonment, Florida

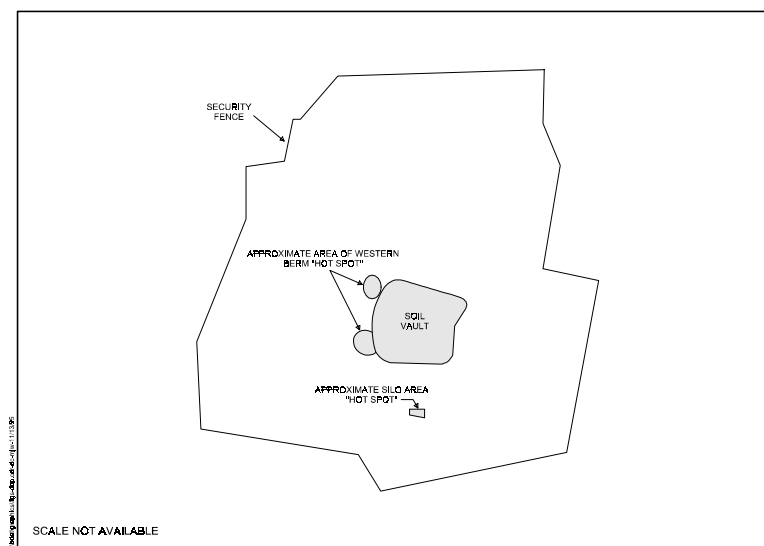
Figure 2. Location of Soil Vault and Hot Spots at DOPC Site [6]

In addition, analyses of soils outside the vault were performed, and several small areas of contaminated soil were characterized, including areas in the western berm of the vault and an on-site silo. The maximum total PAH concentration measured in the soils outside the vault was 367 mg/kg. [6, 31] Figure 2 shows the location of the soil vault, western berm and silo area "hot spots" at the DOPC site.

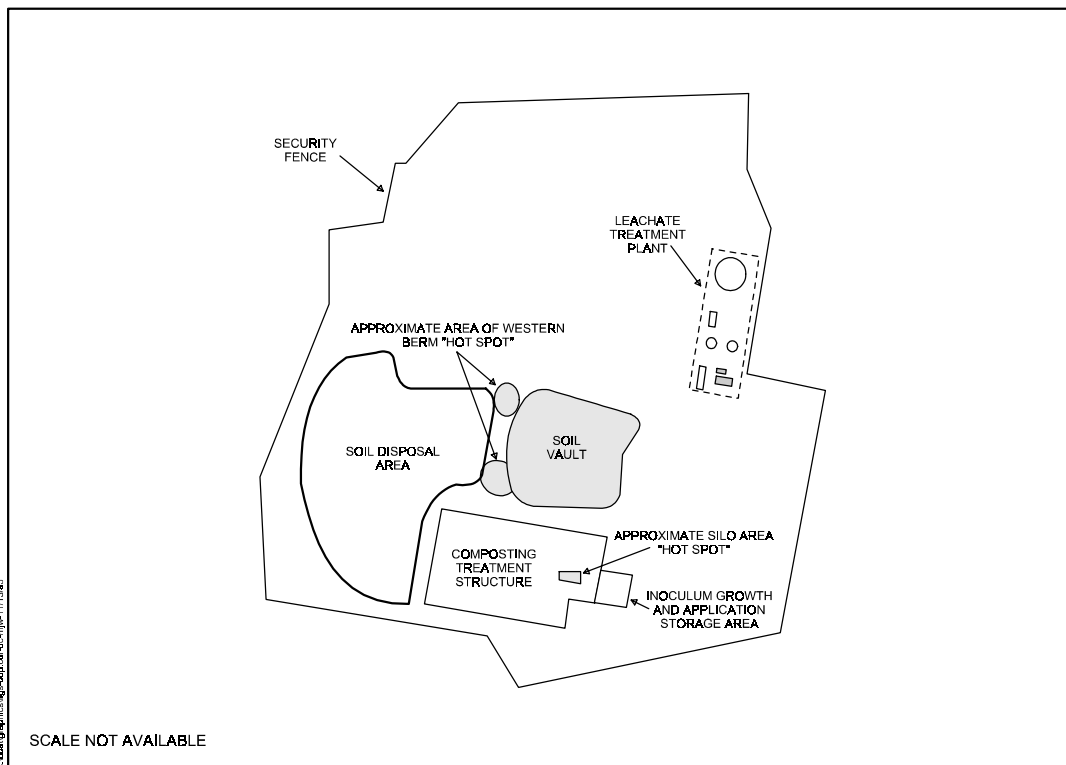
Figure 3. Layout of Major Equipment at DOPC [6]

Figure 3 shows the layout of the major equipment at the site, including the location of the soil disposal area.

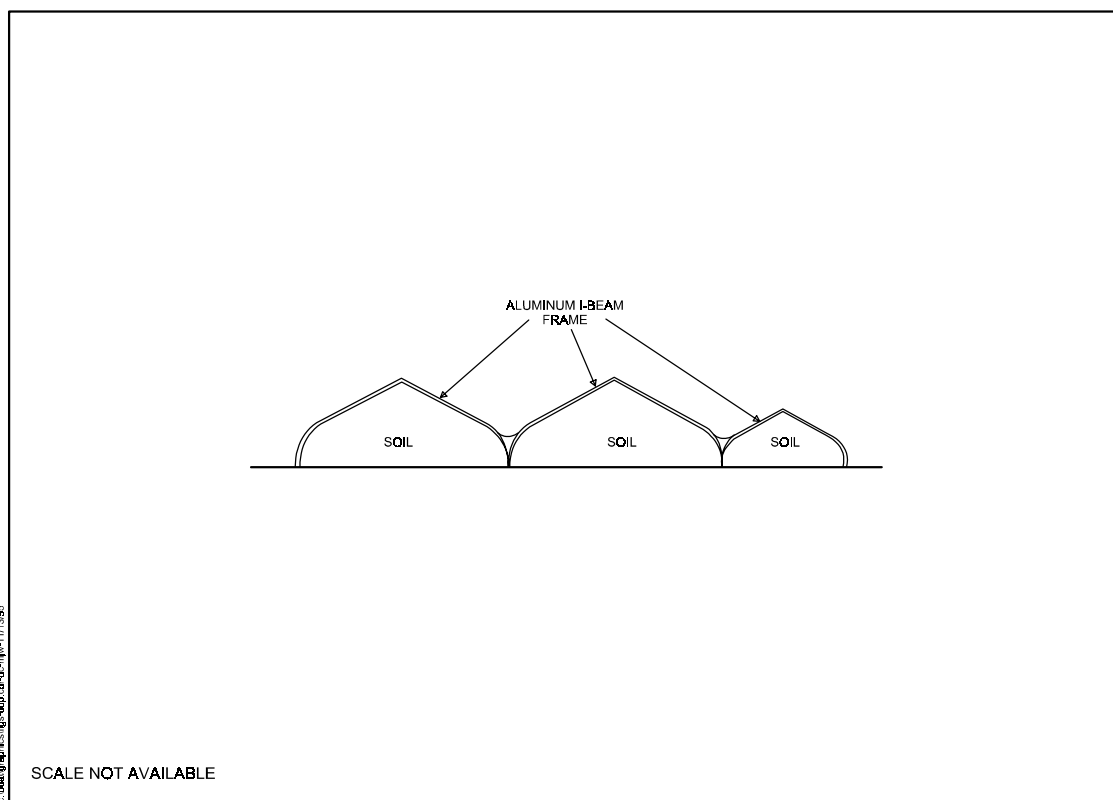
Figure 4. Side View of Treatment Structure [17]

The treatment structure used at DOPC was a 33,000 square foot modular pre-engineered building (approximately 220 by 150 feet) that included three separate units (bays) positioned side by side. The structure was an aluminum I-beam frame structure with reinforced PVC fabric tensioned between the beams. Figure 4 shows a side view of the treatment structure. This structure was leased from Sprung Instant Structures of Fontana, California.

The floor of the structure was covered with a continuous 40 mm low density polyethylene (LDPE) liner which was anchored on top of a continuous 4 foot high wall around the facility. The wall inside of the structure was made of pressure treated lumber reinforced with welded wire mesh.

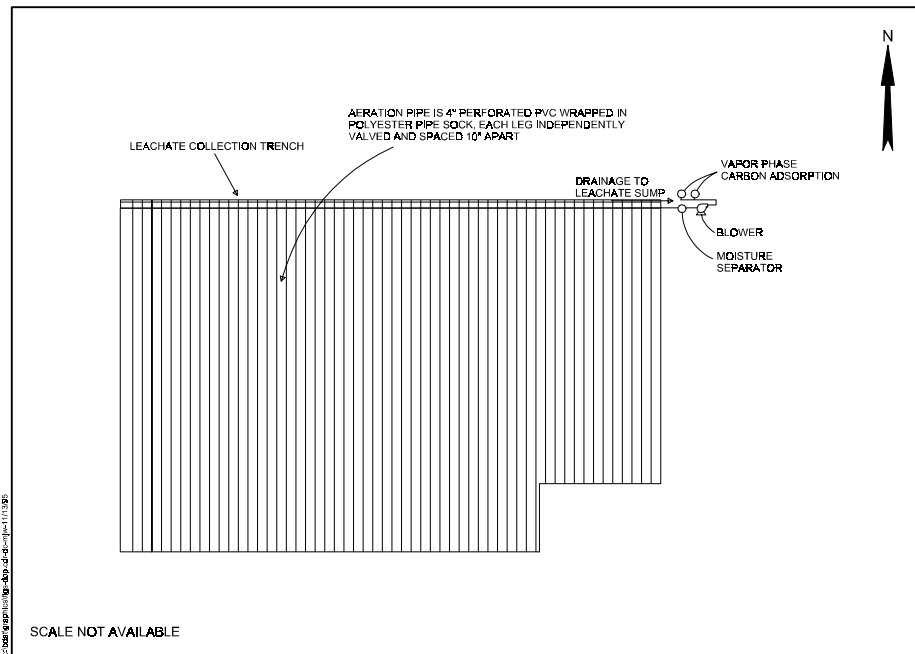
Figure 5. Layout of Aeration System Used at DOPC (top view) [17]

The aeration system used at DOPC, shown in Figure 5, pulled air through the soil placed inside the treatment structure, and consisted of pipes and valves, a moisture separator, a blower unit, and two vapor phase carbon vessels. This system also extracted VOCs from the soil.

The blower unit used at DOPC was a 15 horsepower Rotron EN12 explosion proof regenerative blower, which pulled approximately 300 cubic feet per minute (cfm) of air at a vacuum at 80 to 90 inches of water.

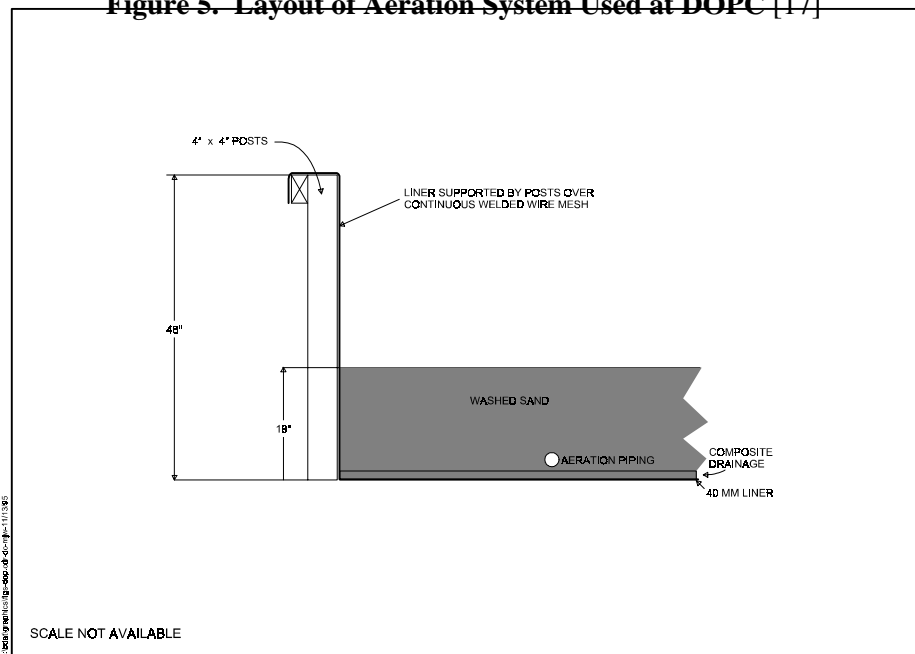
Figure 6. Location of Aeration Piping at DOPC [17]

Approximately 3,000 feet of aeration piping were installed throughout the treatment structure on top of the composite drainage mat, and below the 18 inches of filter sand, as shown in Figure 6. The pipes were 4-inch diameter perforated 3034 PVC wrapped in polyester pipe sock, and spaced approximately 10 inches apart.

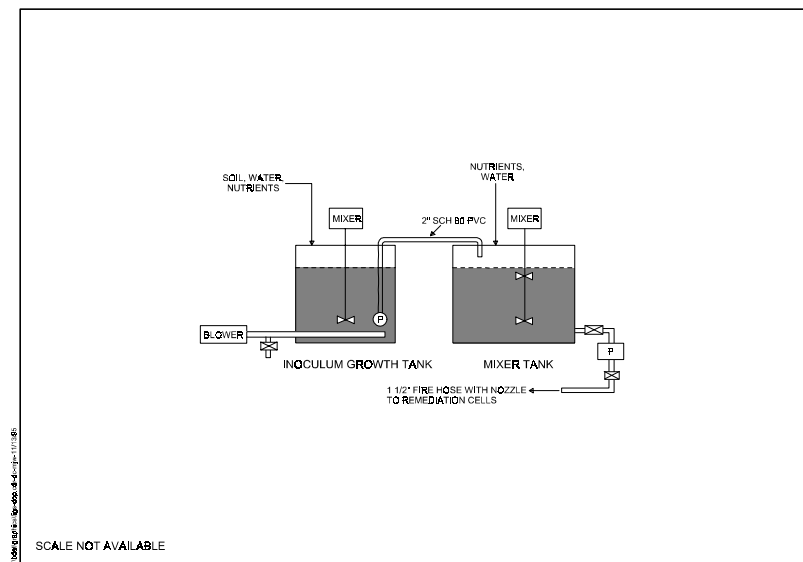
Figure 7. Inoculum Growth and Application System Schematic
[17]

The inoculum growth and application system consisted of two inoculum growth tanks, an inoculum mixing tank, and a pump and fire hose for dispensing the mixture. A schematic of this system is shown in Figure 7. Two 2,000-gallon polyethylene tanks were used to grow the inoculum, using indigenous site soil, water, nutrients, and air. Indigenous site soil was found to contain sufficient microbial activity to support the composting process. Inoculum was allowed to grow for at least 7 days before use in the treatment structure.

The inoculum mixing tank was a 5,000-gallon polyethylene tank equipped with a Lightnin Vector 1-1/2 horsepower high speed mixer operated at 750 rpm. A portion of the inoculum from the growth tank was mixed with additional nutrients and water in this tank. The inoculum mixture was pumped from the mixing tank using a Pulsafeeder centrifugal pump and a firehose and nozzle at 20 gallons per minute.

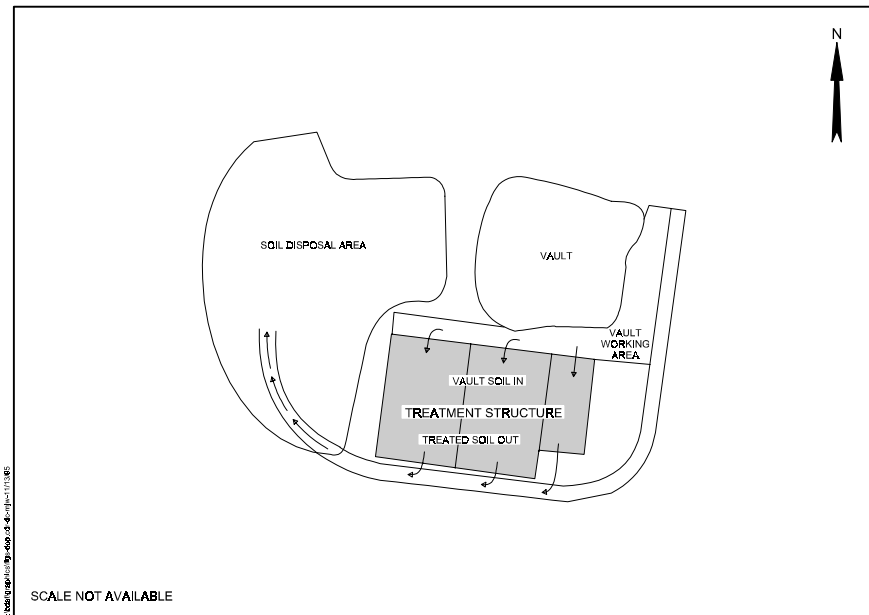
Figure 8. Schematic Showing Movement of Soil [18]

According to the PRP steering committee oversight contractor, the composting system treated all soil batches to the cleanup levels within 14 to 30 days. In addition, the contractor stated that 88% of the soil was treated to meet the cleanup goals within 14 days; however, no data supporting this percentage are provided in the available references. As shown in Figure 8, contaminated soil was transported from the soil vault or other hot spot to the treatment structure. Treated soil was then transported to an on-site soil disposal area.
